CS-3e RFI modification

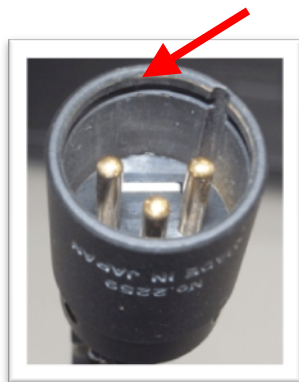
For better RFI rejection, the mechanical contact between the CS-3e's output connector and the mic cable must be improved.

Remove the black paint inside the connector shell using sand paper.

Caution! Only remove the paint, not the black plating under the paint surface.

For best contact with the female connector, remove paint from the locking groove.

Take care not to scrape away any metal or the connector may not lock properly.

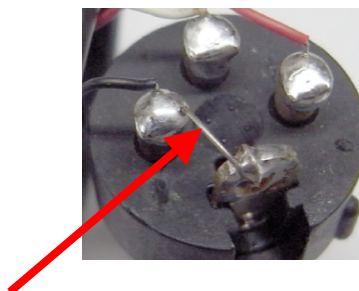
Another source of RFI symptoms can be microphone cables themselves. By nature, clear sounding highly detailed microphones can expose noise which is amplified further though the audio chain. Cables that work in certain circumstances may not suffice with sensitive high performance microphones in certain other environments or systems. It is strongly recommended that any cables in use with the CS-3e have their shells properly grounded to pin 1. Historically not all mic cables were wired this way but in today's RF rich environment the practice is essential.
